Manhole Inspection Summary

Manhole # S63G__010MH

Insp Date: **5/7/08 2:25 PM**

Location Address: **5700 Bayview Blvd.**

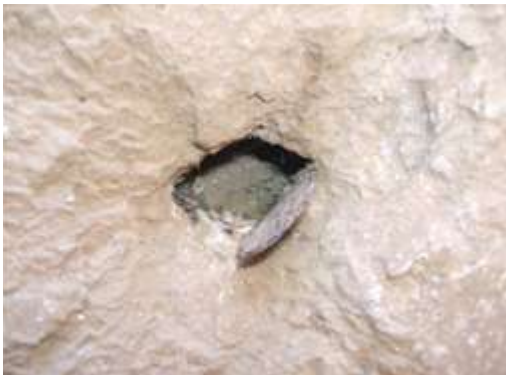
Defect 7

Comments **HOLES IN PRECAST BARREL WALL, VOID VISIBLE**

hole in wall

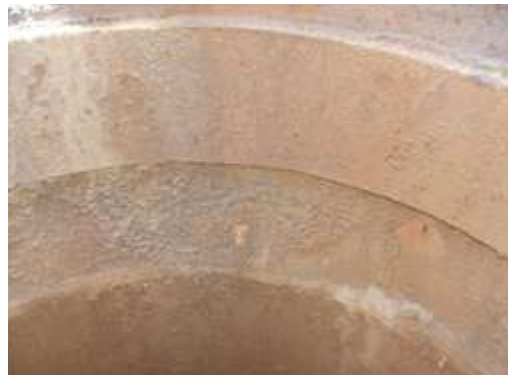
Defect 2

Infiltration: ☐ None ☒ **Joint** ☐ Cracks ☒ **Mortar** ☐ Roots ☐ Wall

infiltration

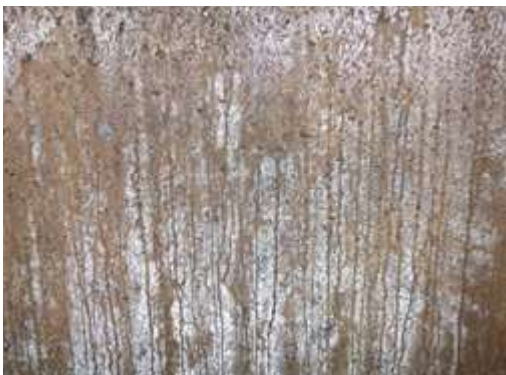
Defect 5

Infiltration: ☐ None ☒ **Joint** ☐ Cracks ☒ **Mortar** ☐ Roots ☐ Wall

infiltration

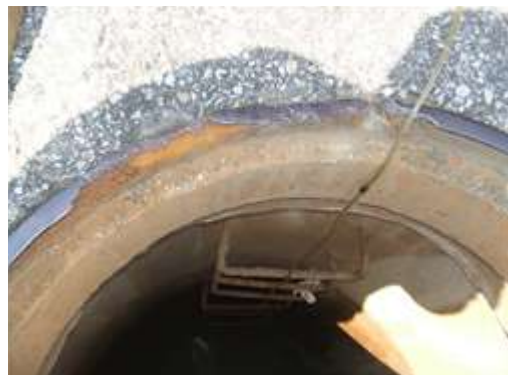
Defect 4

Frame Offset: **0** (in.) Condition: ☐ Sound ☒ **Cracked** ☐ Leaks

cracked frame

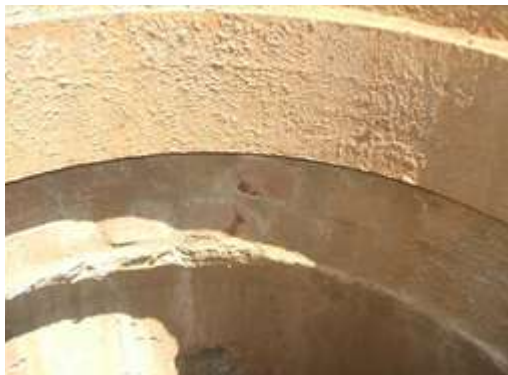
Defect 1

Condition: ☐ Sound ☒ **Cracked** ☐ Root Intrusion ☐ Loose Brick ☐ Deteriorated

crack in chimney

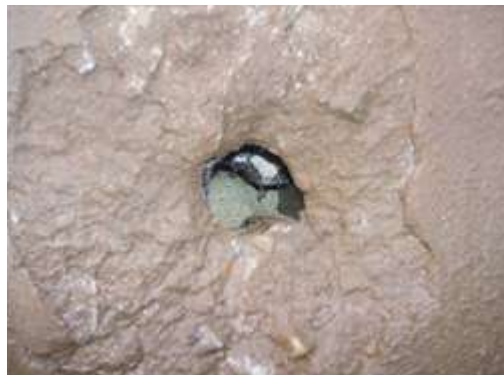
Defect 6

hole in wall

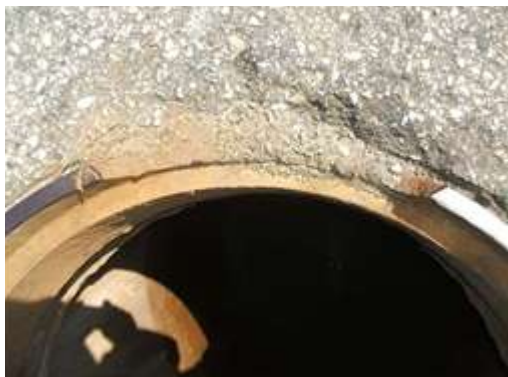
Defect 3

cracked frame

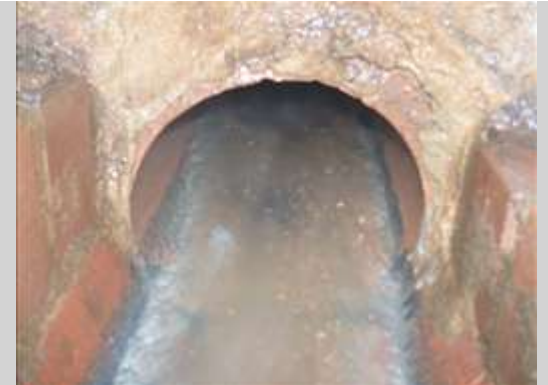
12 O'Clock Outflow

Infiltration: **None** Pipe Seal Cond: **Sound**

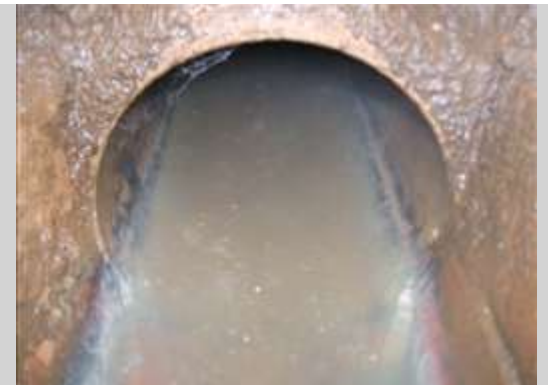
6 O'Clock Inflow

Infiltration: **None** Pipe Seal Cond: **Sound**
